American Airlines 5342 Mid-Air Collision

Location of Incident	Reagan National Airport
Date of Incident	January 29, 2025
Date of Report	DRAFT - March 10, 2025

On January 29, 2025, at 8:47 p.m., a PSA Airlines Bombardier CRJ700 (American Airlines Flight 5342) and a U.S. Army Sikorsky UH-60 Black Hawk collided midair over the Potomac River near Ronald Reagan Washington National Airport, killing 67 people.

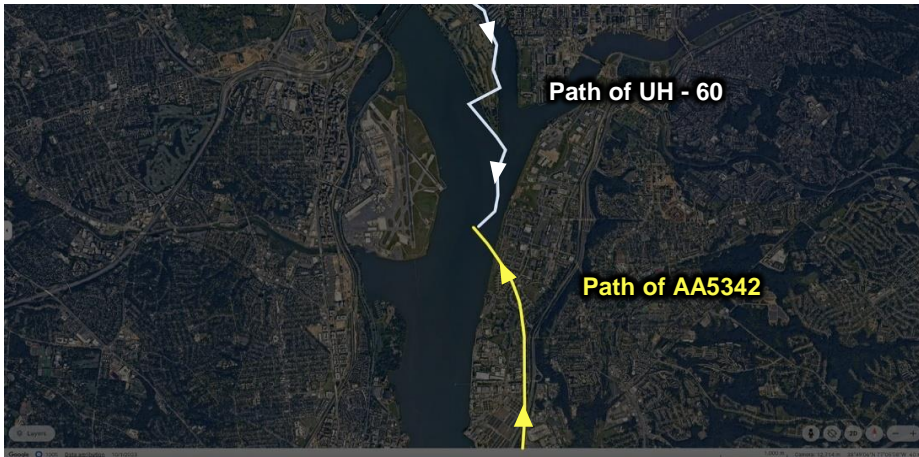
Top down view of AA5342 and UH-60 from top down - Credit Google Earth

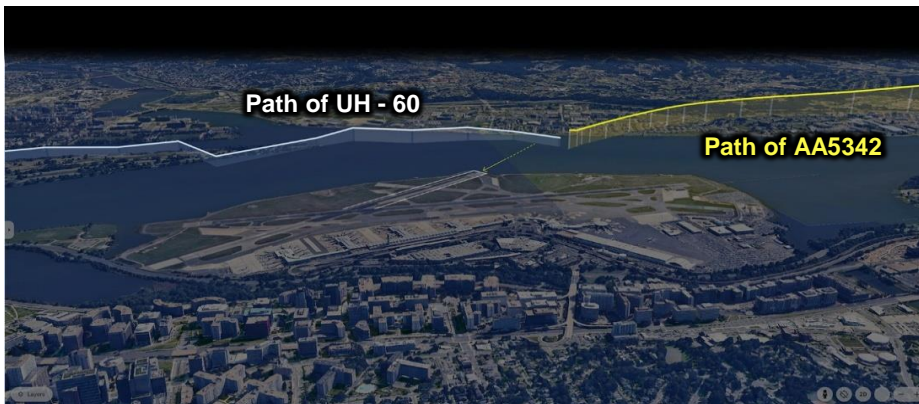
Isometric view of AA5342 and UH-60 - Credit Google Earth

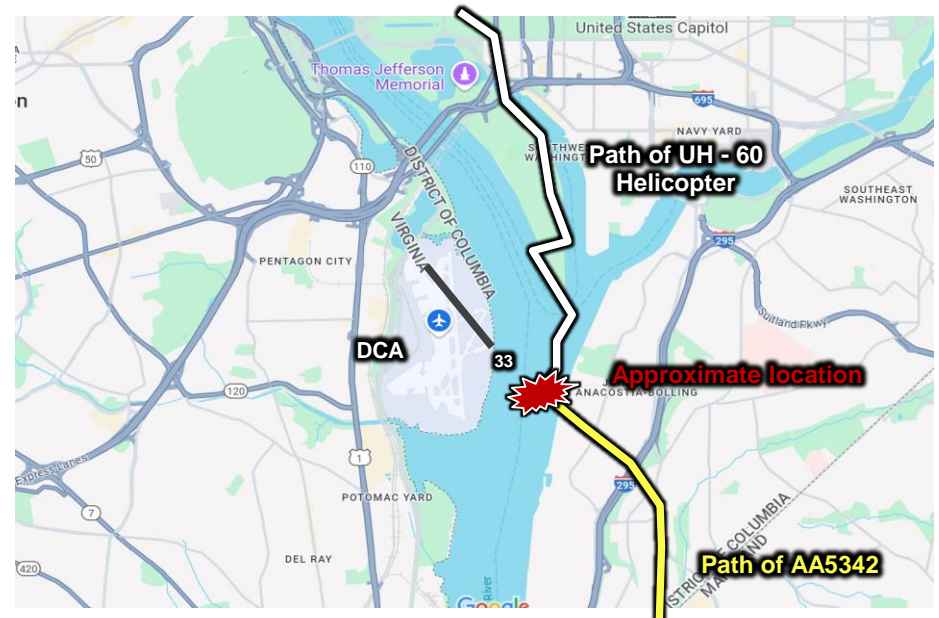
Map of both paths overlaid on Google Maps - Credit Google Maps

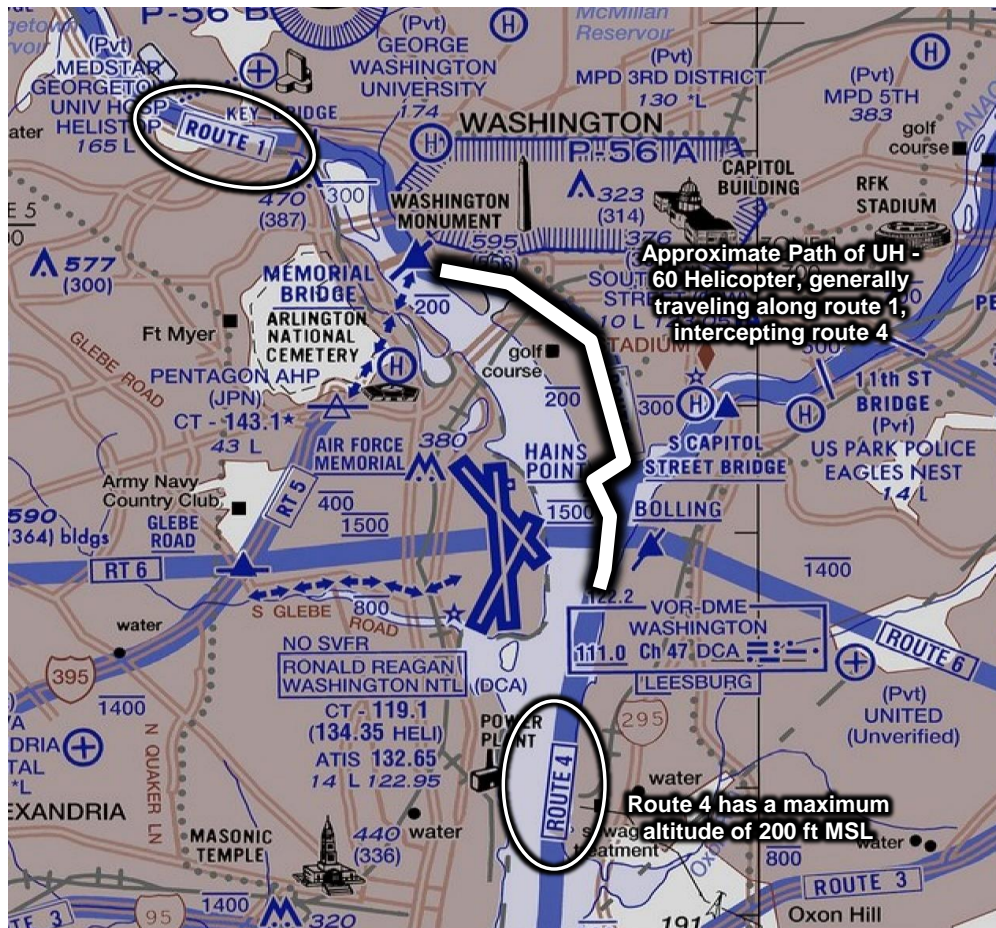
RT 1: AMERICAN LEGION BRIDGE OVER POTOMAC RIVER, EAST OF ROOSEVELT ISLAND TO THE TIDAL BASIN. OVER WASHINGTON CHANNEL TO ANACOSTIA RIVER. NORTHEAST OVER ANACOSTIA RIVER TO RIVERDALE AND VIA BALTIMORE WASHINGTON PARKWAY TO GREENBELT.

ALTITUDES: AMERICAN LEGION BRIDGE AT OR BELOW 1300 FEET MSL, CHAIN BRIDGE AT OR BELOW 700 FEET MSL, KEY BRIDGE AT OR BELOW 300 FEET MSL, MEMORIAL BRIDGE AT OR BELOW 200 FEET MSL NOT ABOVE 200 FEET MSL UNTIL JAMES CREEK MARINA, AT OR BELOW 300 FEET MSL TO 11TH STREET BRIDGE, AT OR BELOW 500 FEET MSL TO PENNSYLVANIA AVENUE, AT OR BELOW 700 FEET MSL FROM PENNSYLVANIA AVENUE TO RIVERDALE, AT OR BELOW 1300 FEET MSL TO GREENBELT. (HELICOPTERS CROSSING POTOMAC RIVER TO OR FROM THE PENTAGON SHALL BE AT OR BELOW 200 FEET MSL).

RT. 4: FORT WASHINGTON OVER POTOMAC RIVER TO WILSON BRIDGE. THEN VIA EAST BANK OF POTOMAC RIVER TO ANACOSTIA RIVER. INTERCEPT ROUTE 1 AT ANACOSTIA RIVER.

ALTITUDES: AT OR BELOW 1000 FEET MSL AT FORT WASHINGTON, DESCEND TO 600 FEET MSL ABEAM BROAD CREEK INLET, BEGIN DESCENT FROM 600 FEET MSL TO ARRIVE AT 300 FEET MSL OVER WILSON BRIDGE, THEN AT OR BELOW 200 FEET MSL NORTH OF WILSON BRIDGE.

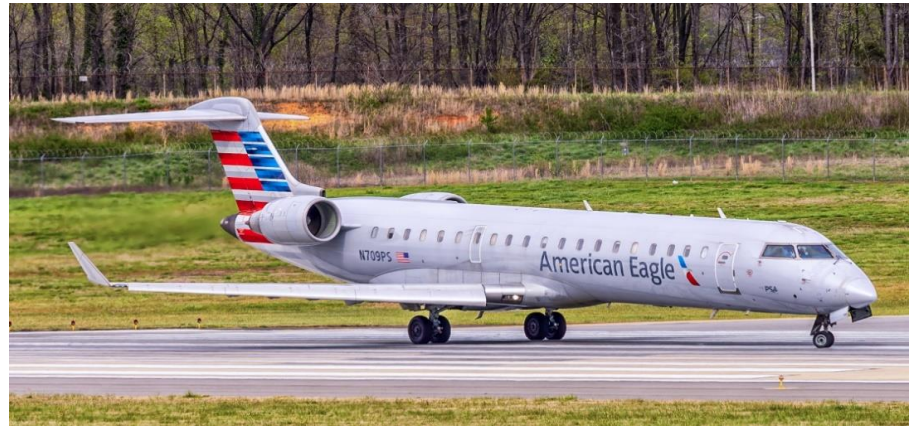
AA5342 N709PS CRJ-700 involved in DCA mid-air collision
Credit: Wikipedia

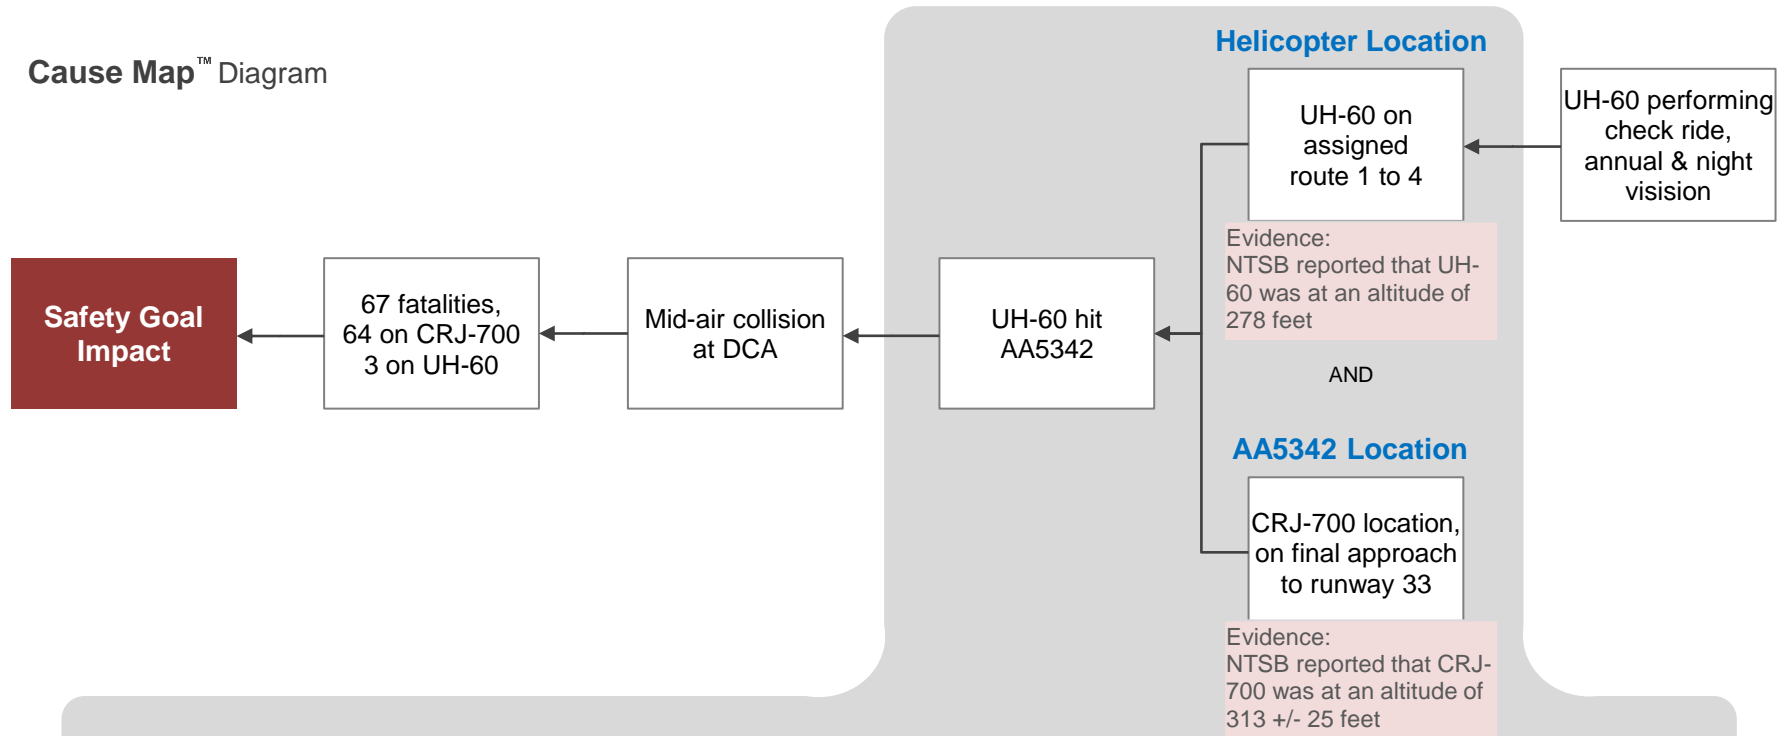
In this incident, in order for the effect "Helicopter (UH-60) hit Airplane (AA5342) to occur, it requires both the helicopter and the airliner to be in the exact same place, at the same time.

The Helicopter (UH-60) hit Airplane (AA5342) because the UH-60 was on Route 1 to 4, AND the CRJ-700 was on final approach.

Because of this relationship, we can either control either the location of the helicopter or the airliner to lower the risk of this incident occurring again.
