American Airlines 5342 Mid-Air Collision

Location of Incident	Reagan National Airport
Date of Incident	January 29, 2025
Date of Report	DRAFT - March 10, 2025

On January 29, 2025, at 8:47 p.m., a PSA Airlines Bombardier CRJ700 (American Airlines Flight 5342) and a U.S. Army Sikorsky UH-60 Black Hawk collided midair over the Potomac River near Ronald Reagan Washington National Airport, killing 67 people.

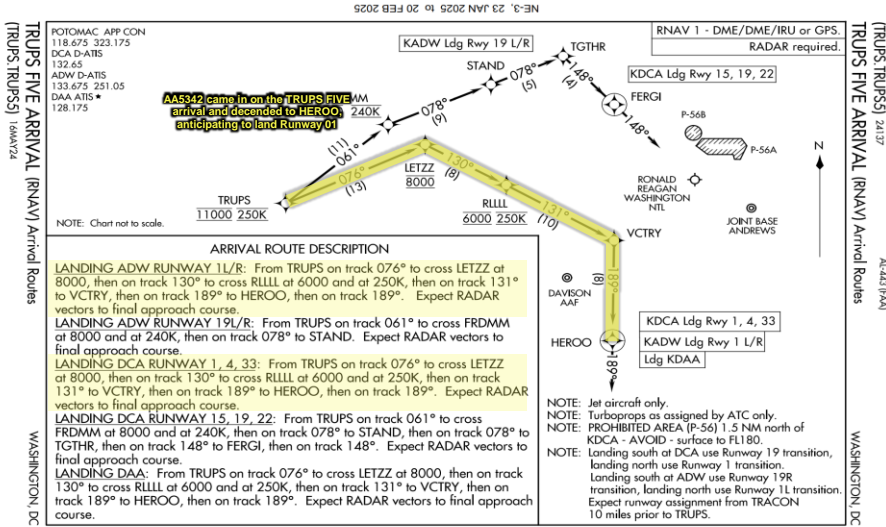
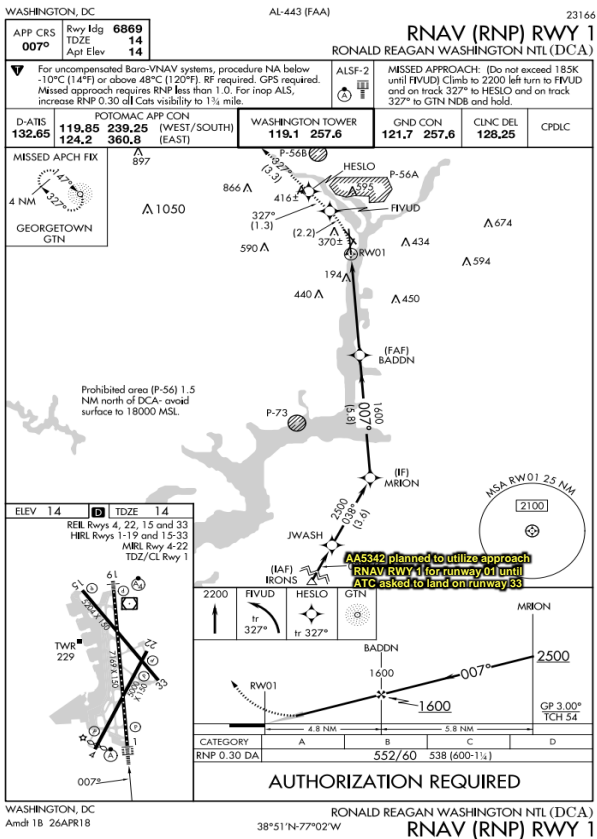
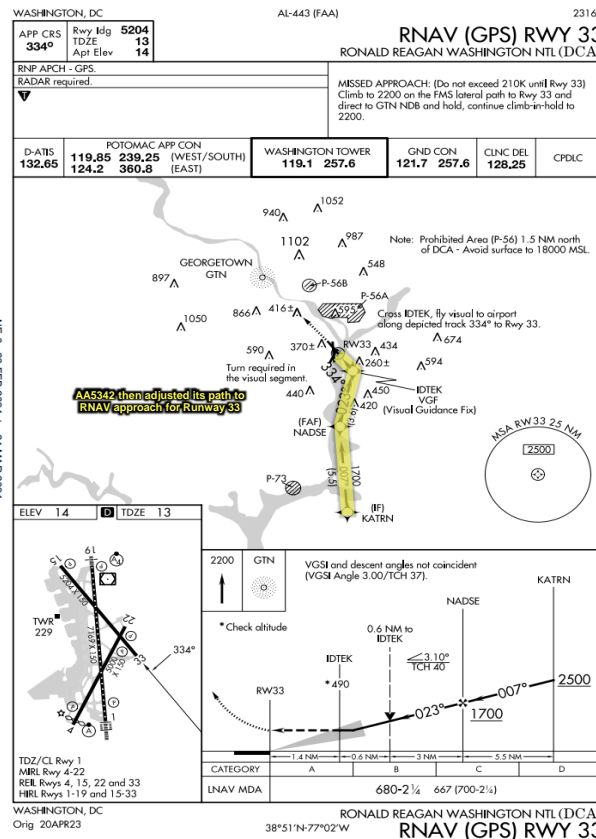
Diagrams

Map of both paths overlaid on Google Maps - Credit Google Maps

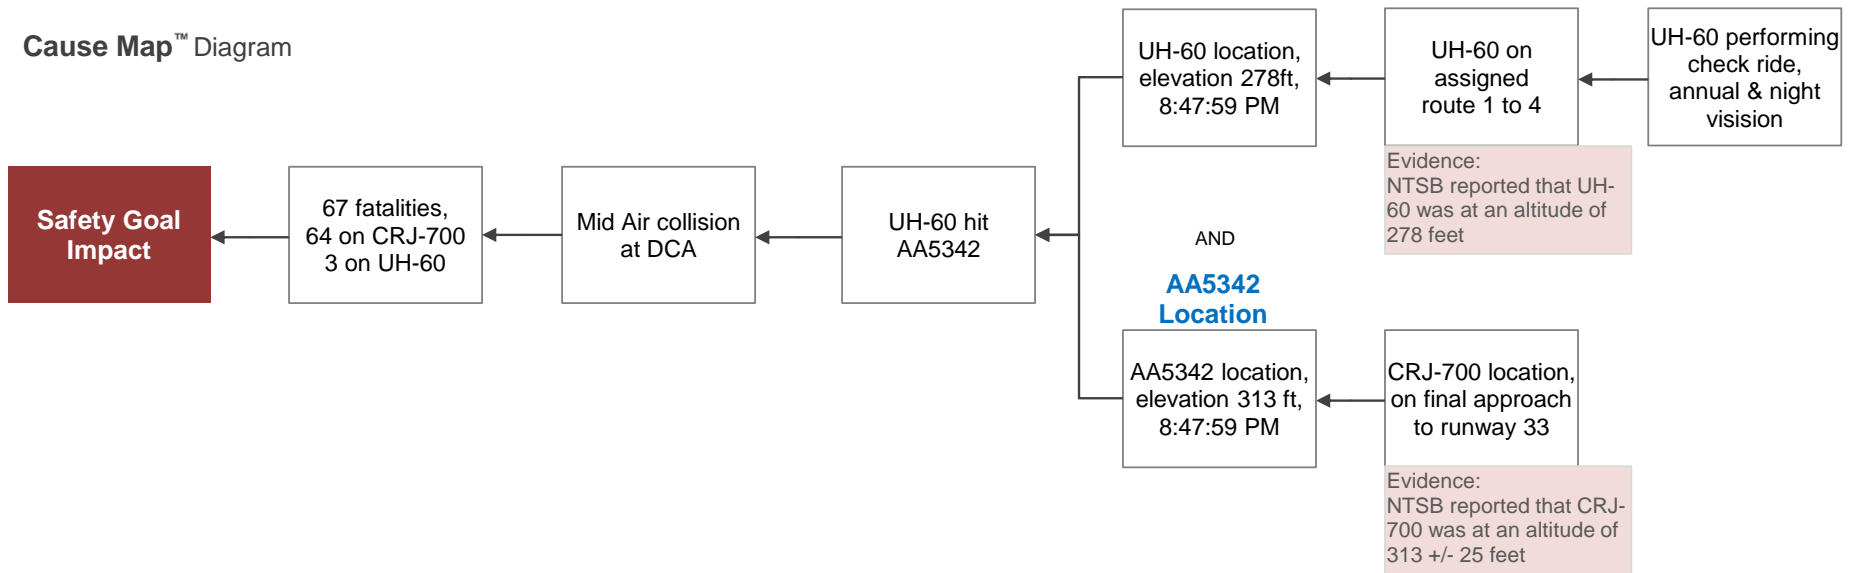
Cause Map™ Diagram

The subsequent Cause Maps will continue to ask the "Why" question to try and reveal more causes related to this incident
